2011 Barber Lake Septic Survey

*Barber Lake
Town of Winter
Sawyer County, Wisconsin*

Sawyer County Sanitarian-----Eric Wellauer
Sawyer County Zoning and Conservation Technician-----Jay Kozlowski
Zoning and Sanitation Intern-----Joel Murray

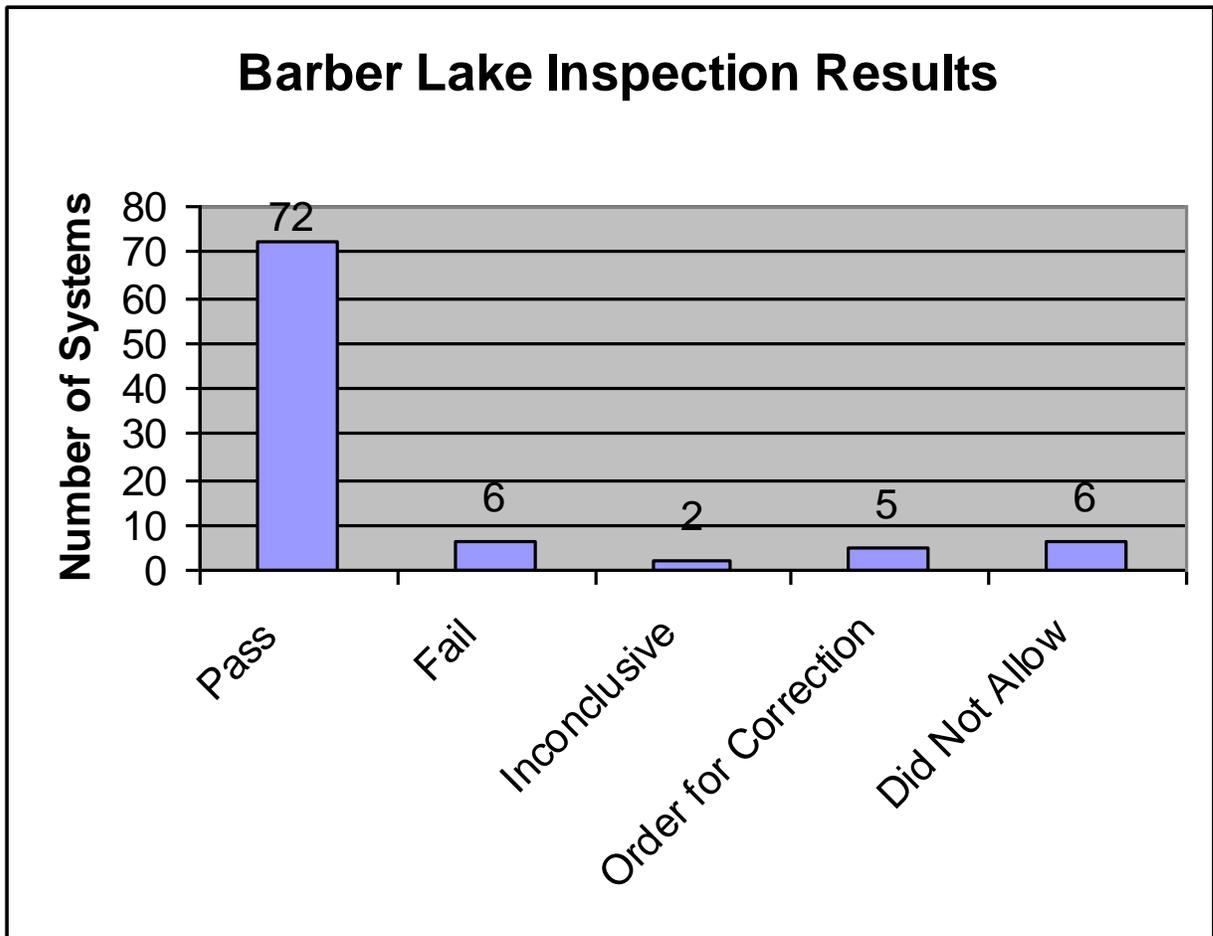
Graph 1

Pass/Fail (See Graph 1)

There were a total of 91 systems on Barber Lake. Of the 91 systems, 72 passed inspection, 6 systems failed inspection, 2 systems were inconclusive, and 6 had other issues for “order for correction”. 6 systems could not be inspected because the homeowner denied the inspection to occur. Of the 6 failing systems, 3 were old drywells, 2 were conventional bed systems, and 1 was classified as other.

Results	Number of systems	Percentage
Pass	72	79%
Fail	6	7%
Inconclusive	2	2%
Order for Correction	5	5%
Did Not Allow	6	7%
Total	91	100%

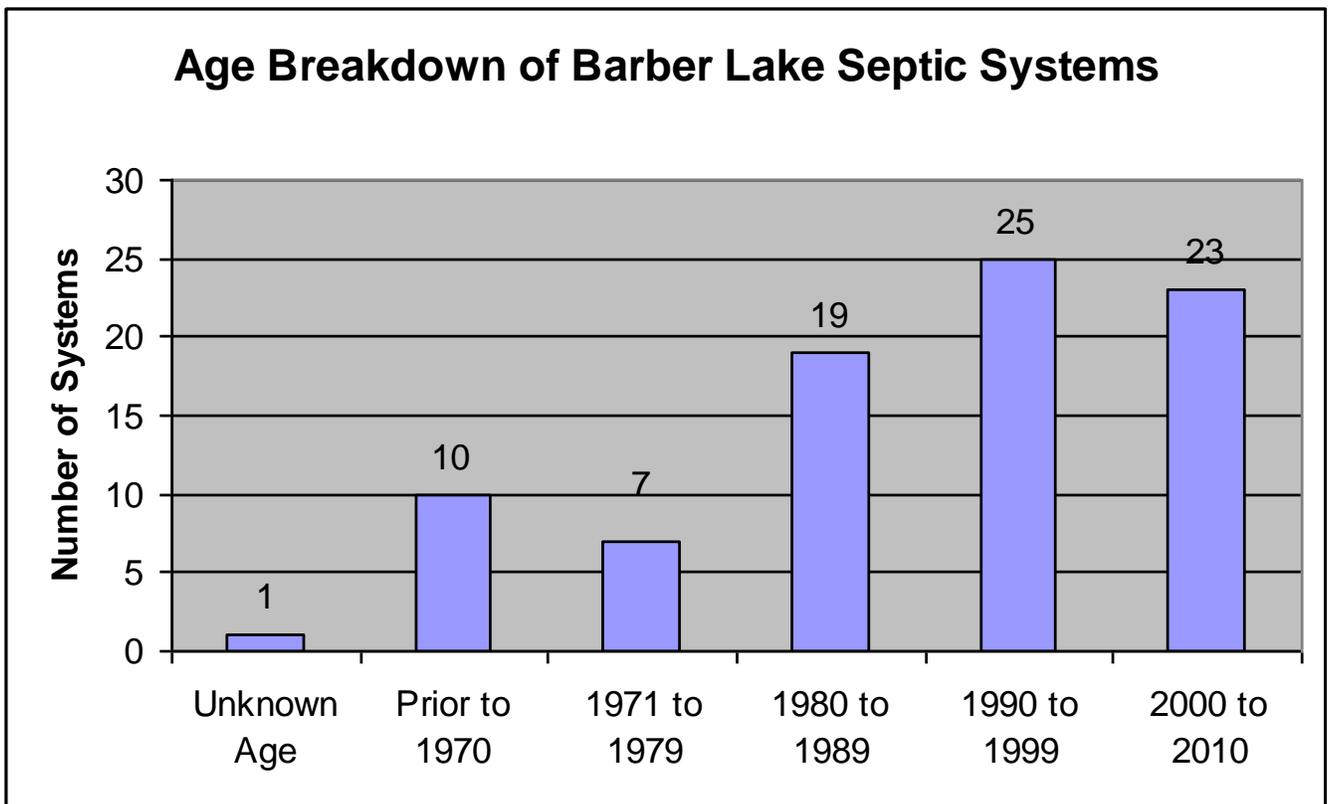
Graph 2

Age of Systems

Year Range	Number of Systems	Percentage
Unknown Age	1	1%
Prior to 1970	10	12%
1971 to 1979	7	8%
1980 to 1989	19	22%
1990 to 1999	25	29%
2000 to 2010	23	27%
Total	85	100%

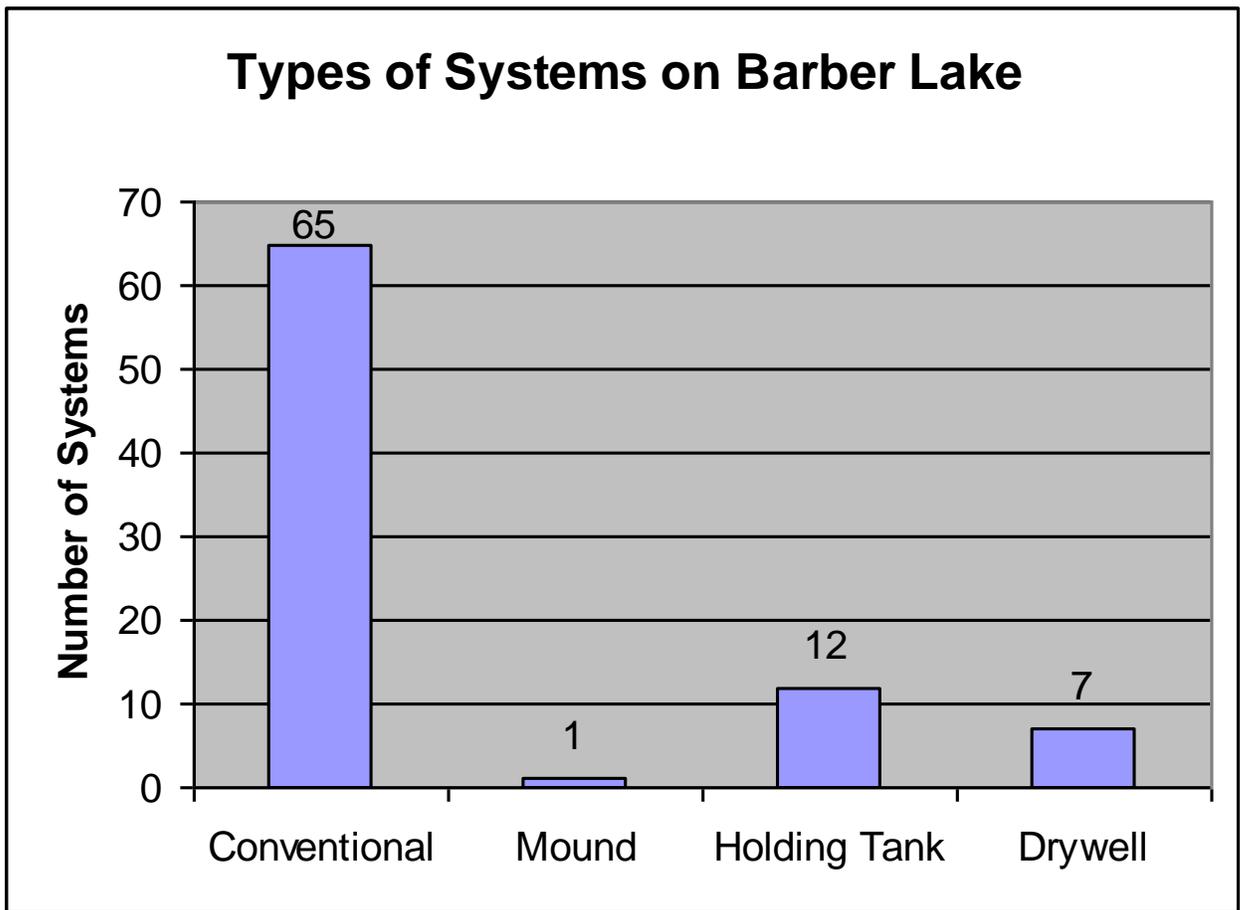
Graph 3

Of the total systems inspected, 65 (76%) were of the conventional type. 7 (8%) drywells were inspected, with 4 of those drywells passing inspection, generally due to elevation, and no visible signs of failure such as effluent on the ground or a collapsed

tank. These drywells were installed 30-50 years ago, and are most probably undersized by today's standards. There was 1 (1%) mound system and 12 (14%) holding tanks located in low lying areas with soils inadequate for in ground systems.

Types of Systems

Types of Systems	Number of Systems	Percentage
Conventional	65	76%
Mound	1	1%
Holding Tank	12	14%
Drywell	7	8%
Total	85	100%

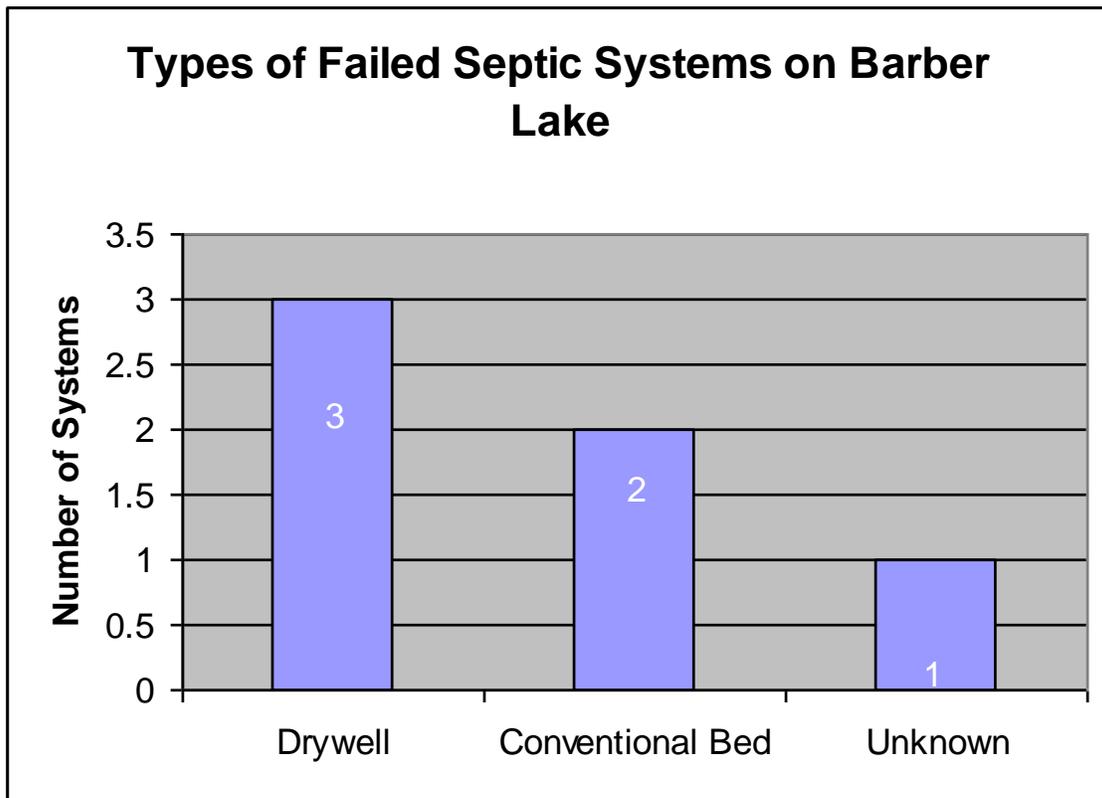
Graph 4

Reasons for failure (See Graph 4)

A total of 6 systems failed inspection. Of those, 3 were drywells near or in groundwater. 2 systems were conventional bed systems which failed to meet code based upon their proximity to soil restrictions, and/or groundwater. The other failed system was an unknown type with system elevation near or in groundwater.

Failure Statistics

System Type	Number of Systems	Percentage
Drywell	3	50%
Conventional Bed	2	33%
Unknown	1	17%
Total	6	100%
