# Land, Water and Forest Resources Committee Agenda

Thank you for requesting a report addressing the condition of Fish Trap Lake Dam. We inspected the overall condition of the dam but in particular, with respect to the deformation of the corrugated metal outlet pipes. Both outlet pipes are bent upward. The deformation was not reported on the DNR inspection report dated 09/22/2009. In addition to our visual inspection a soil boring was performed near the north edge of the north outlet pipe, plus a groundwater observation well was installed immediately south of the south pipe. Refer to the plan sheet for location.

This is the Department of Natural Resources' Dam Safety Report based on our inspection of the FISHTRAP LAKE DAM on 9/22/2009. This report identifies work that needs to be done on the dam and a schedule for when that work is to be completed. Please contact me if you have questions about the needed repairs or are uncertain how to proceed.

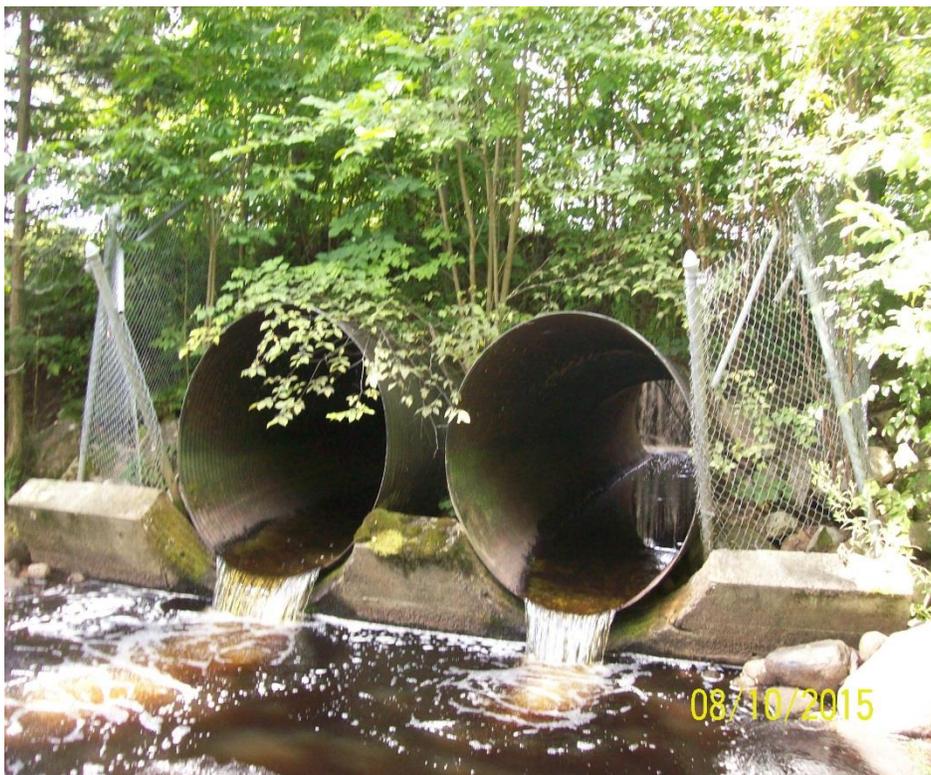
The downstream support wall has failed and is tipping out. The wall prevents undermining of the pipes but provides very little support. The rotation of the wall may have provided uplift on the end of the outlet pipes adding to the deformation of the outlet pipes. The deformation can be seen in the north pipe (the pipe on the right). The chain link fence is distorted. Trees and brush have overgrown the slope.

- Repair the deteriorated concrete. Concrete repair will include: surface preparation, seal all cracks in the concrete, surface repair of all concrete abrasion.
- Remove and replace the stop logs.
- Straighten the top of the south outlet pipe (in the south drop box – see photo).
- Remove the security fence.
- Cut all brush and trees, removing the roots down to 1” diameter.
- Remove the downstream concrete endwall.
- Beginning on the downstream end, excavate and expose both outlet pipes up to the point where the pipes are bent upward and distorted. At that point cut and remove both of the exposed 6’ diameter outlet pipes, beveling the ends to match the side slope. Install heavy rip rap over geotextile fabric

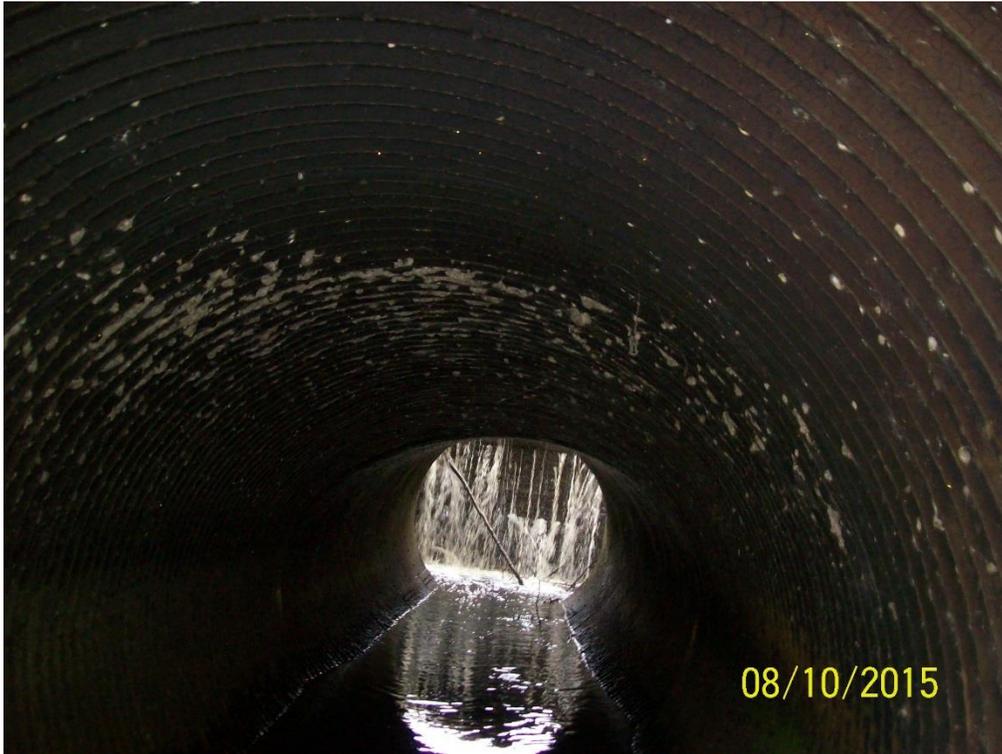
Looking down the top of the north pipe – showing the deformation approximately midway along the length of the pipe.

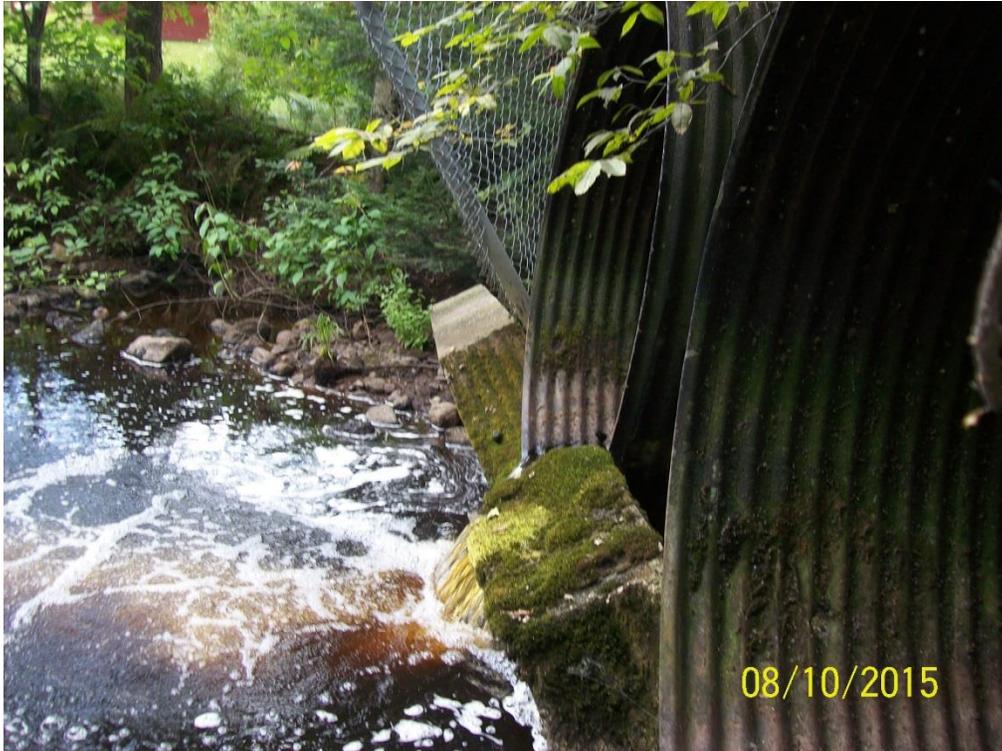
The outlet support wall has rotated downstream creating an upward force on the end of both outlet pipes.

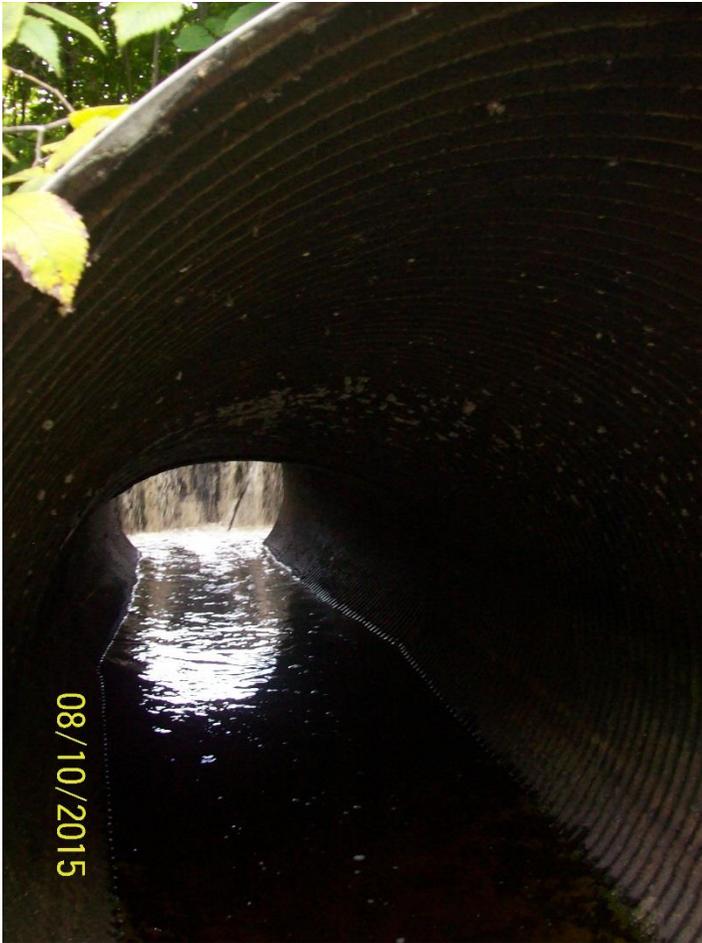
The deformation in the south pipe is more than the north pipe. The pipe joints are still intact and are not leaking.

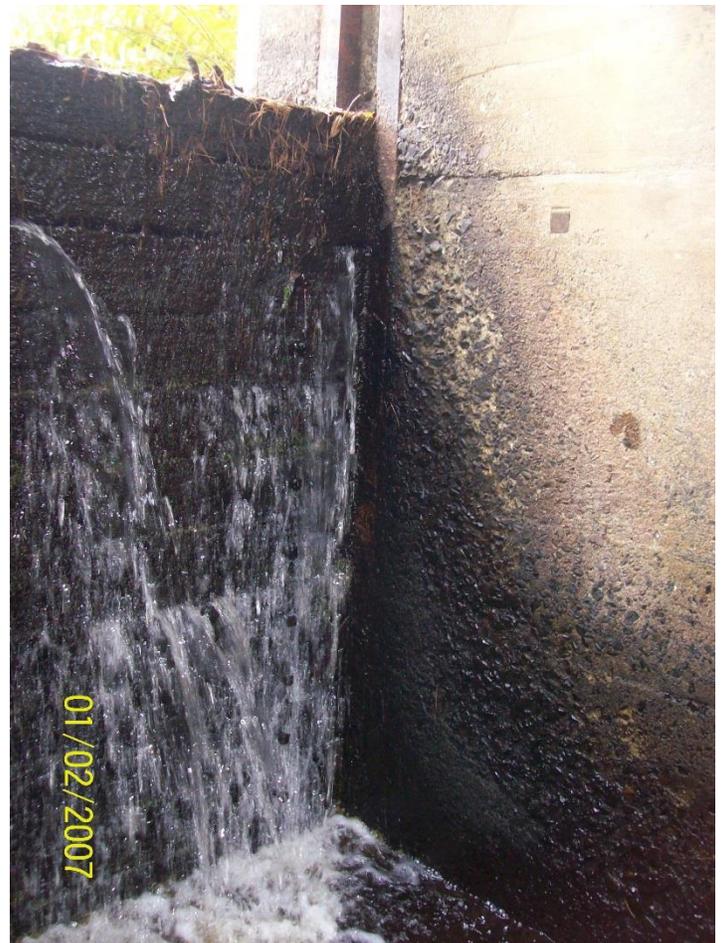
Looking from inside of the north stop log box, all flow is coming from leakage through the stop logs. The concrete surface has lost fine aggregate and cement paste from water abrasion. There is also concrete loss at the forming joint near the top of the stop logs.

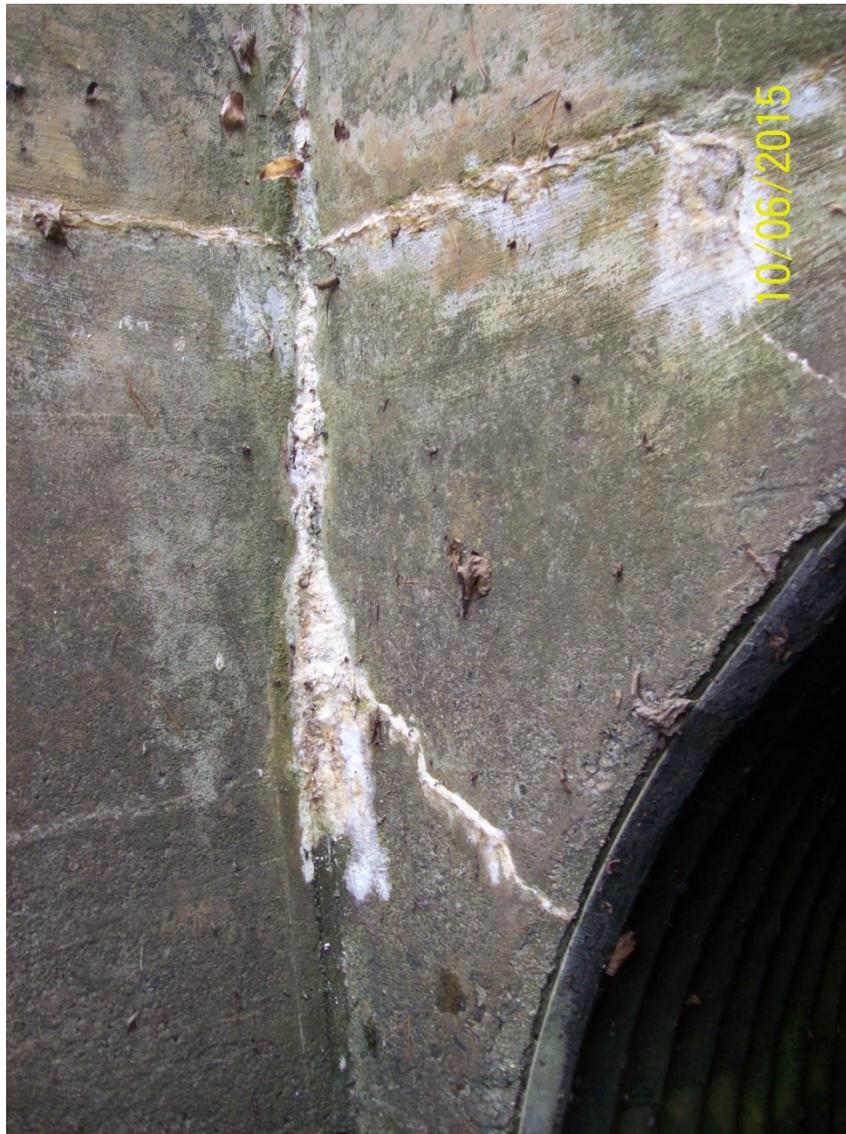
This is the northeast corner of the north box. Cracks in the concrete are showing efflorescence caused by passage of moisture.

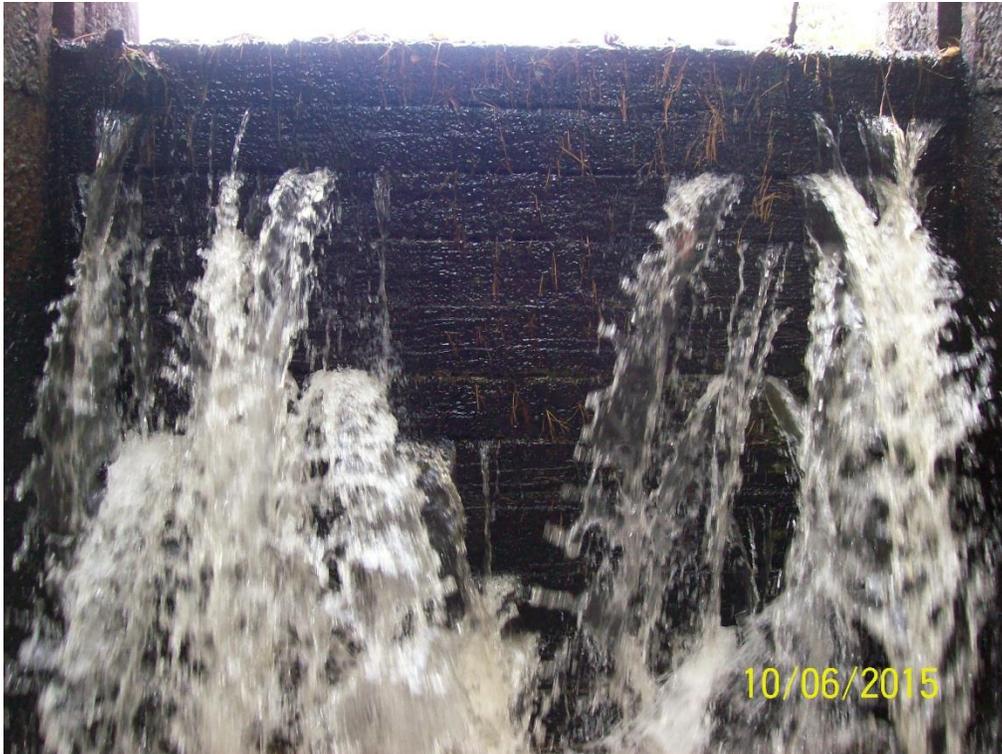
There is significant leakage through the stop logs in the south drop box.

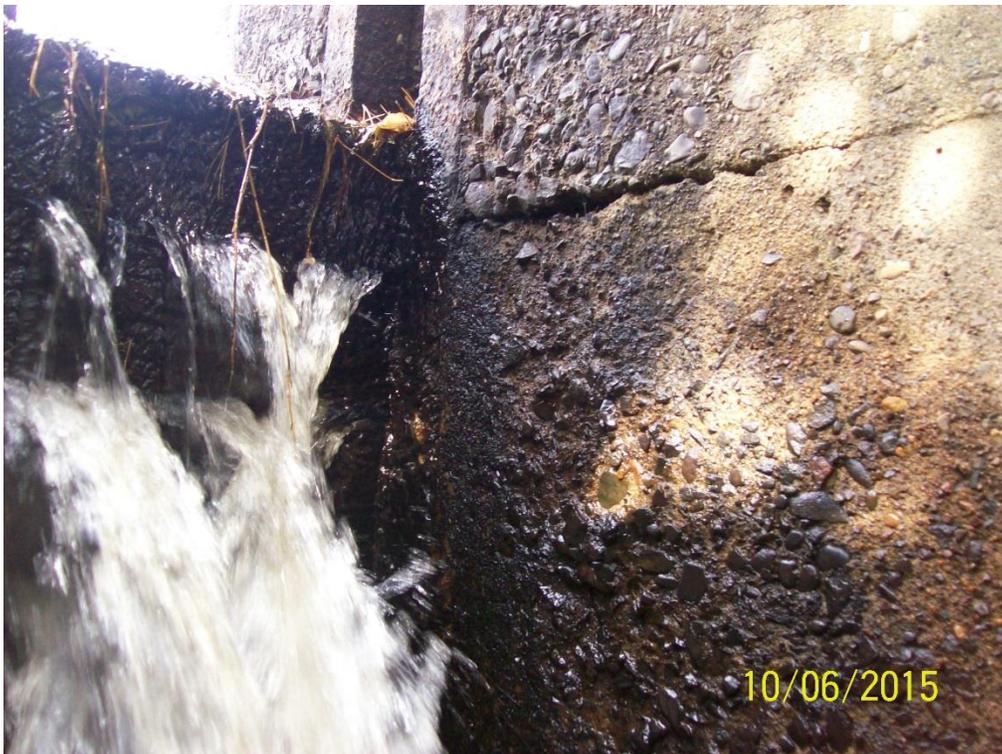
The south drop box also has concrete surface abrasion and loss of concrete at the construction joint near the top of the stop logs.

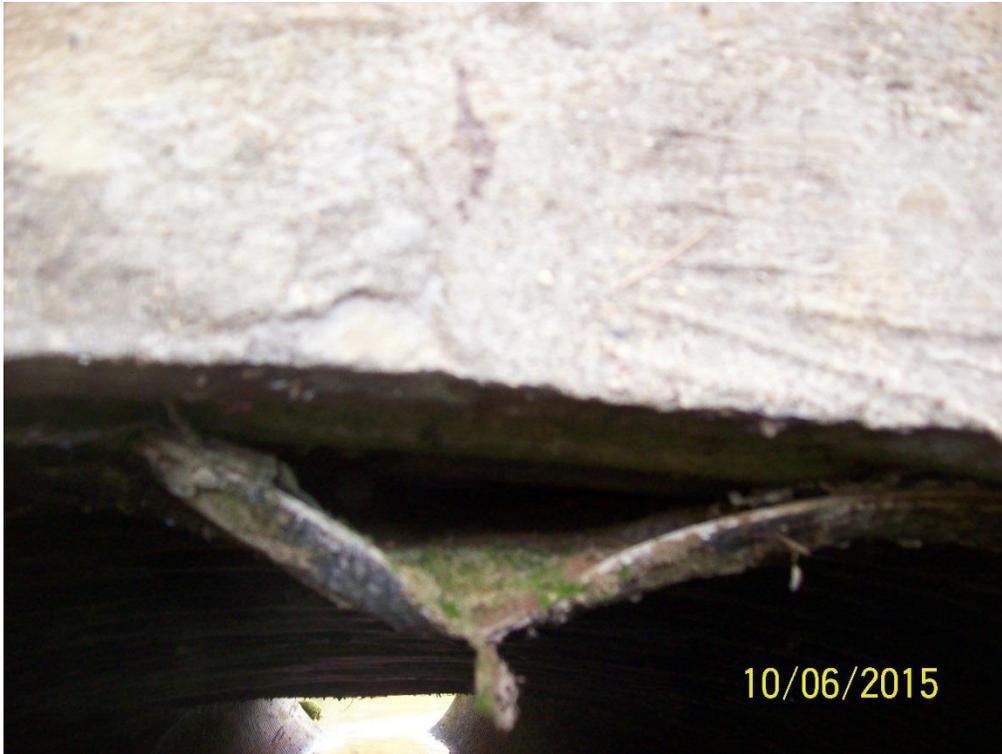
The top of the south pipe at the inlet has minor damage from being impacted by debris.

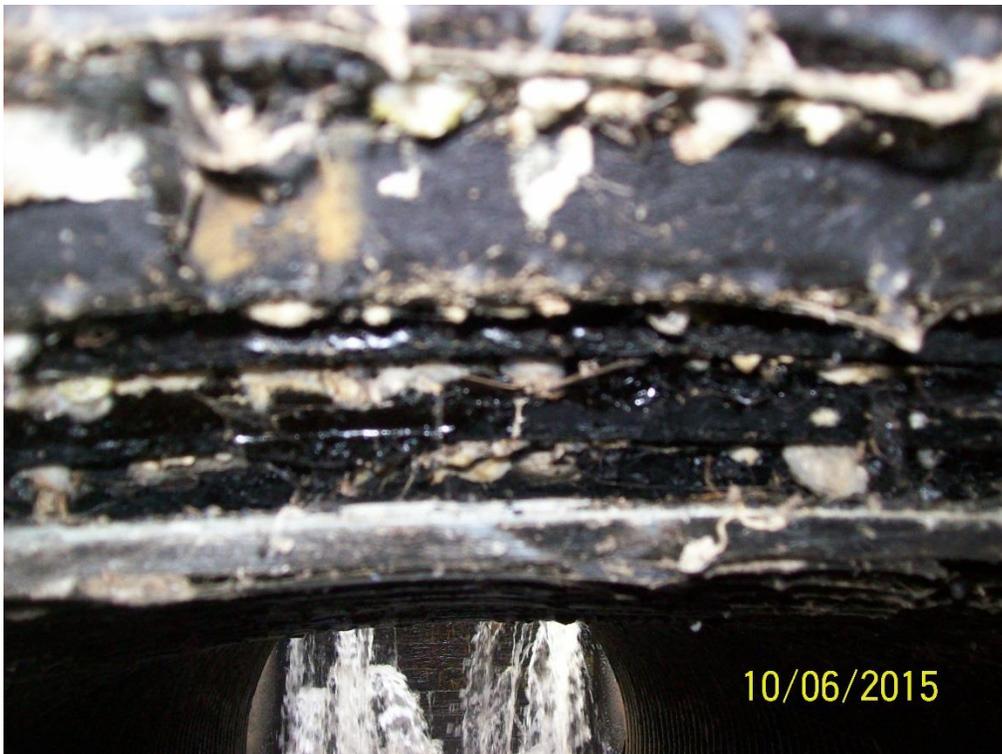
This photograph was taken from inside the south pipe at the point of maximum deformation. Shown is the top of the pipe at the pipe joint. The joint is pulled upward but not leaking. The bow or bend in the top of the pipe can be seen very clearly in this photo.

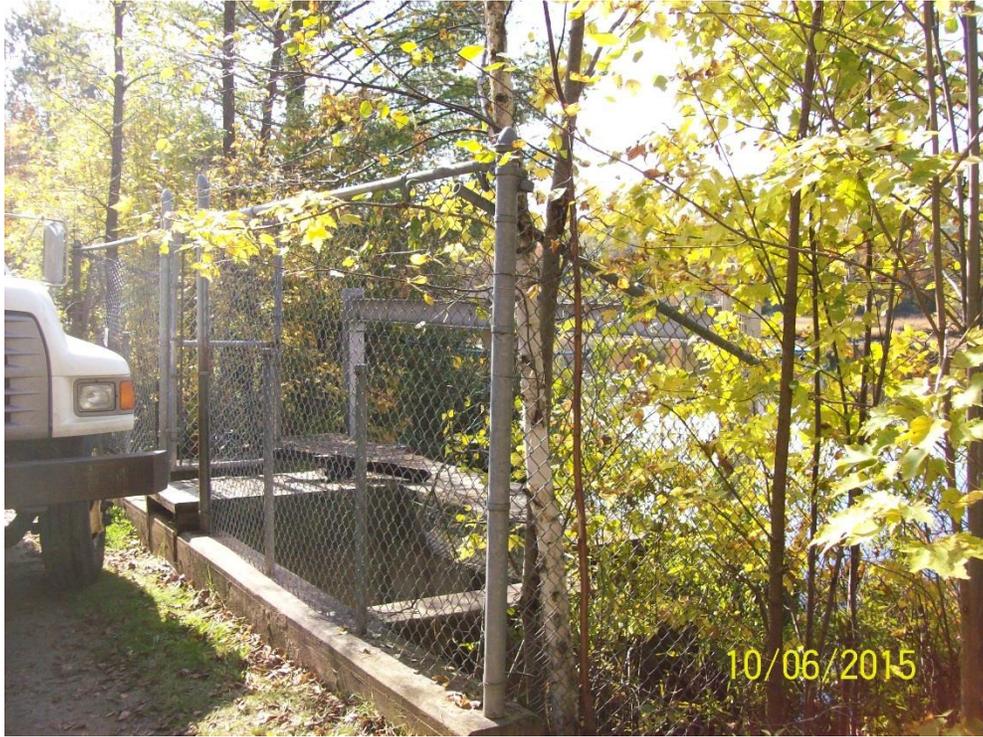
The two drop boxes, located on the lake side, are shown in this photograph. At this location the security fence is in good condition. Trees and brush need to be cut and removed.

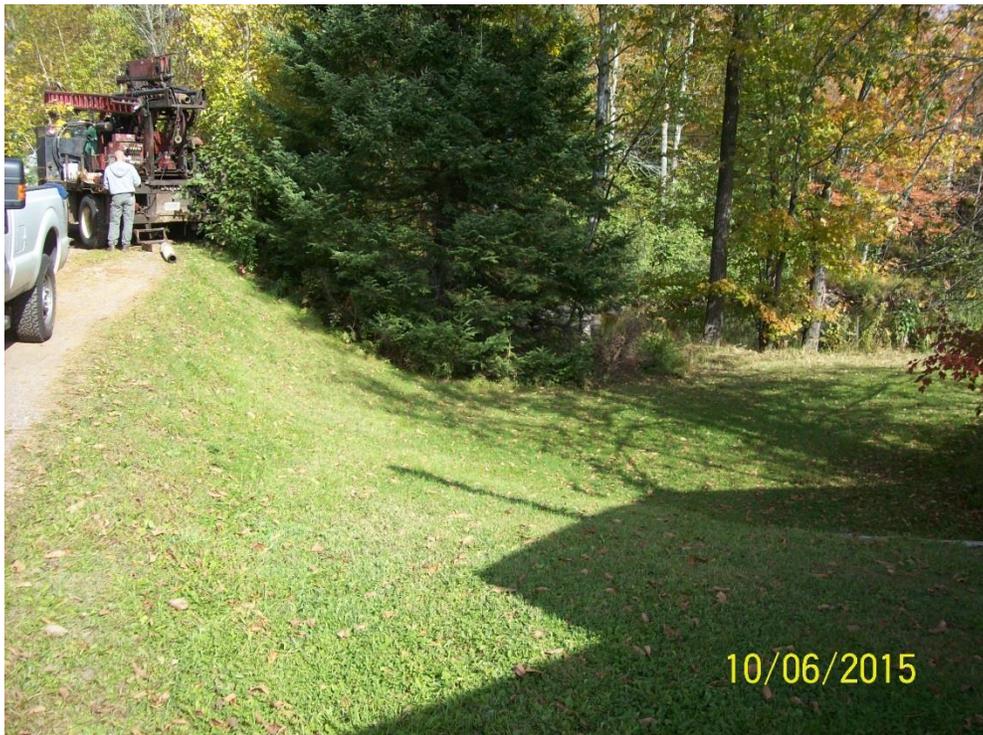
This is the right downstream berm. The downstream berm is steeper than 3:1 and trees are present on the slope. The shadow on the lawn is from the resort.

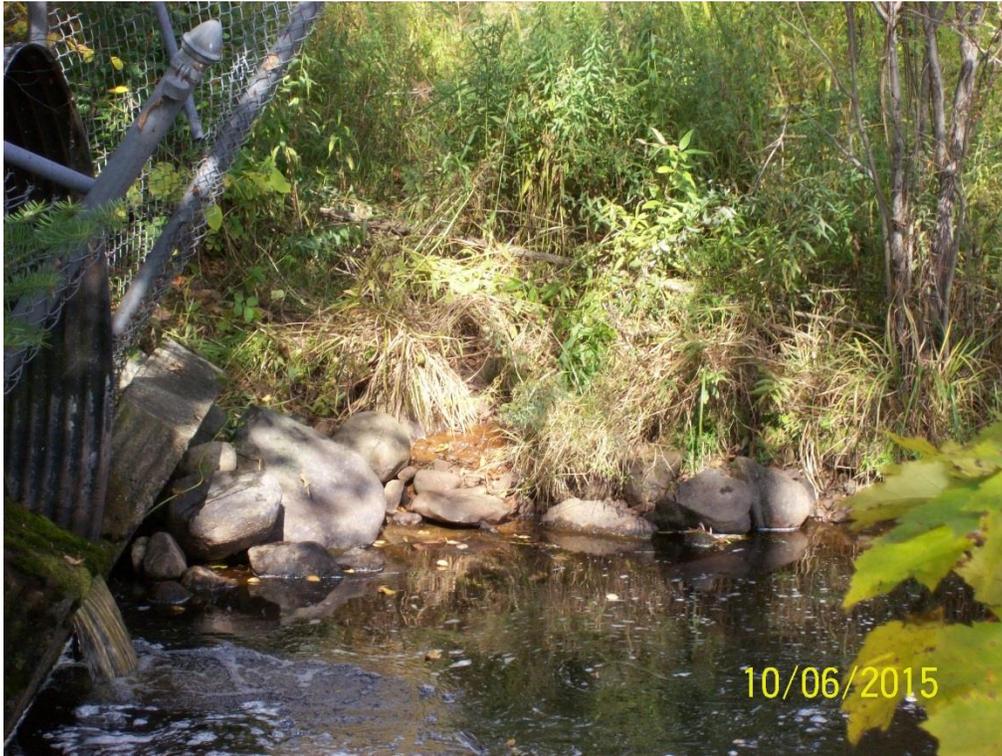
On the north bank seepage is present indicating flow of water through the berm. The yellow brown water results when the seepage is exposed to oxygen in the air.

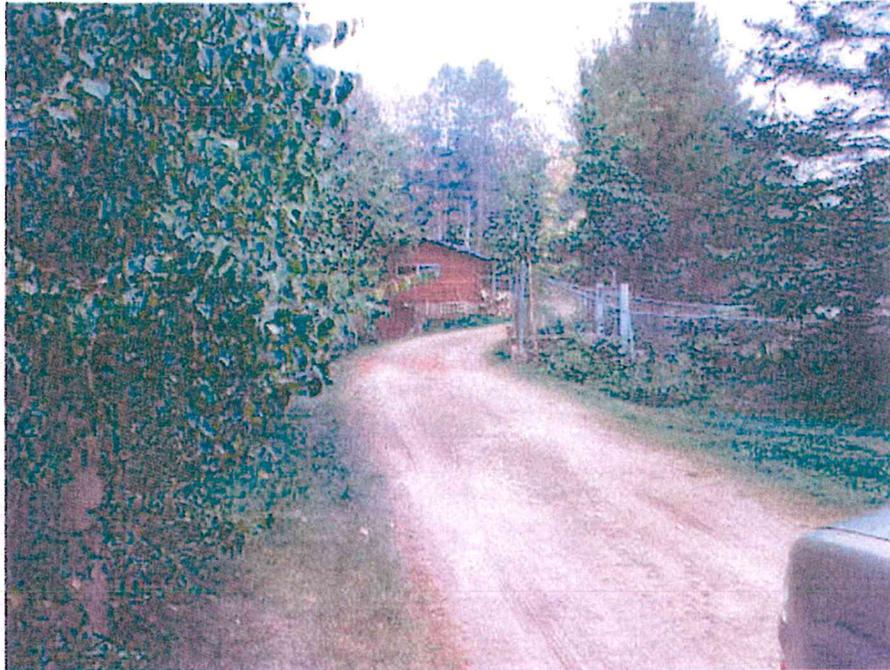
**Figure 1**  
**Crest of Fishtrap Lake Dam**  
**Trees and Woody Vegetation must be removed**

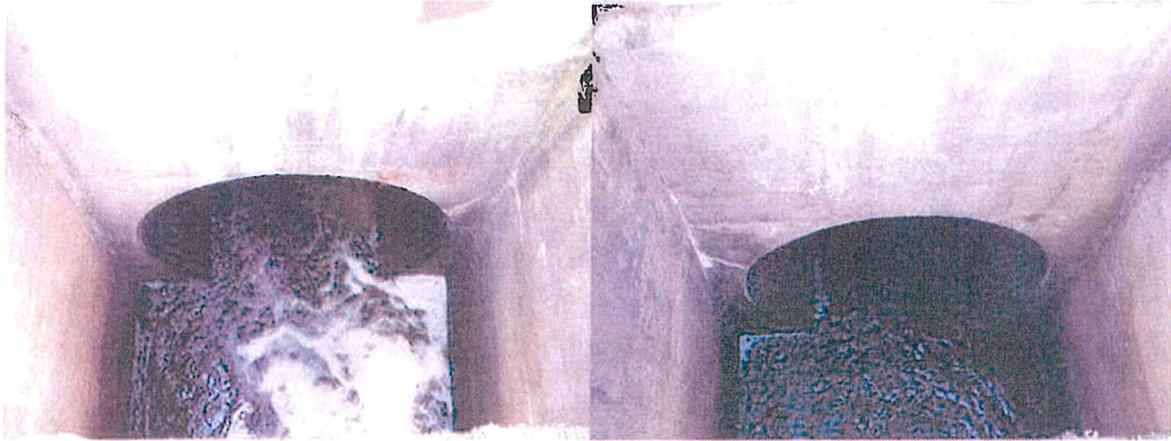
The concrete of the spillway, while old, is still in fairly good condition. Some hairline cracks were observed in the abutments and headwalls for the culvert flow-ways (See Figure 4). Minor spalling was

**Figure 4**  
**Flow-Ways**

also apparent. Please monitor the deterioration of the concrete and have your engineer make recommendations for repair as it continues to age.

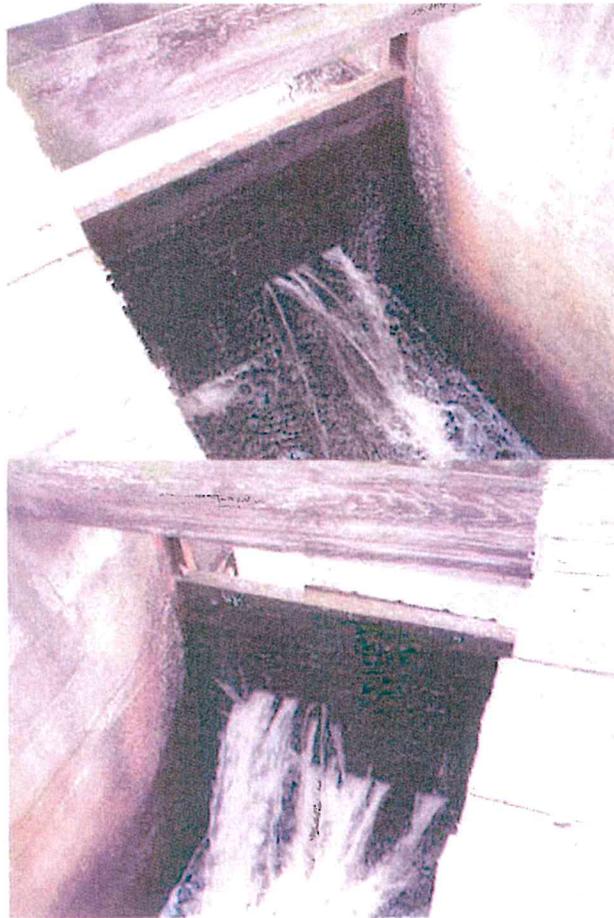
The stoplogs in both the left and right bays are leaking (See Figure 5). They did not appear to be structurally inadequate but you need to monitor them so that you can replace the logs before they fail.

**Figure 5**  
**Leaky Stoplogs**

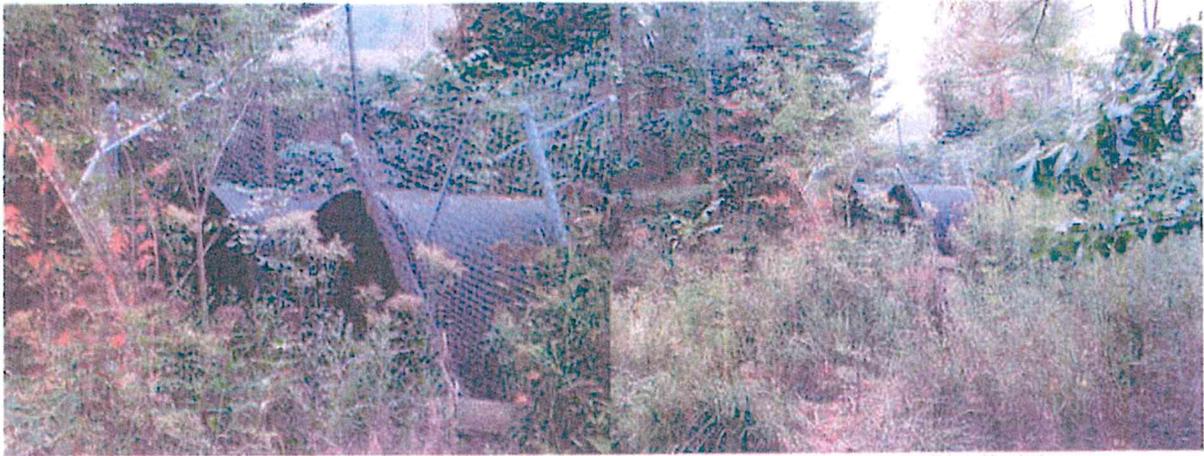
The embankment of the dam is in fair condition. Some woody vegetation is growing on both the right and left, and this must be removed (See Figures 6 & 7). I saw no evidence of slope instability, such as slides or bulges. However, it will be easier to monitor the embankment with the vegetation managed. Please maintain a well-mowed grass embankment on both right and left, upstream and downstream.

**Figure 6**  
**Outlets – Vegetation/Brush must be controlled**

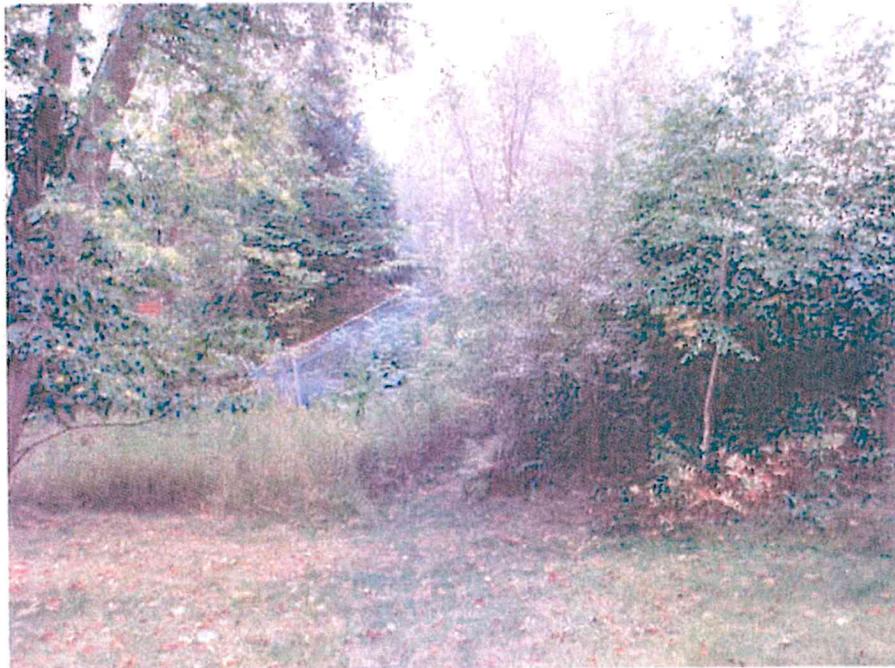
**Figure 7**  
**Trees and Vegetation on both right and left sides should be maintained as a thick grass cover, mowed regularly. Woody vegetation around the concrete, pipes and within 20 feet of toe of slope must be removed.**

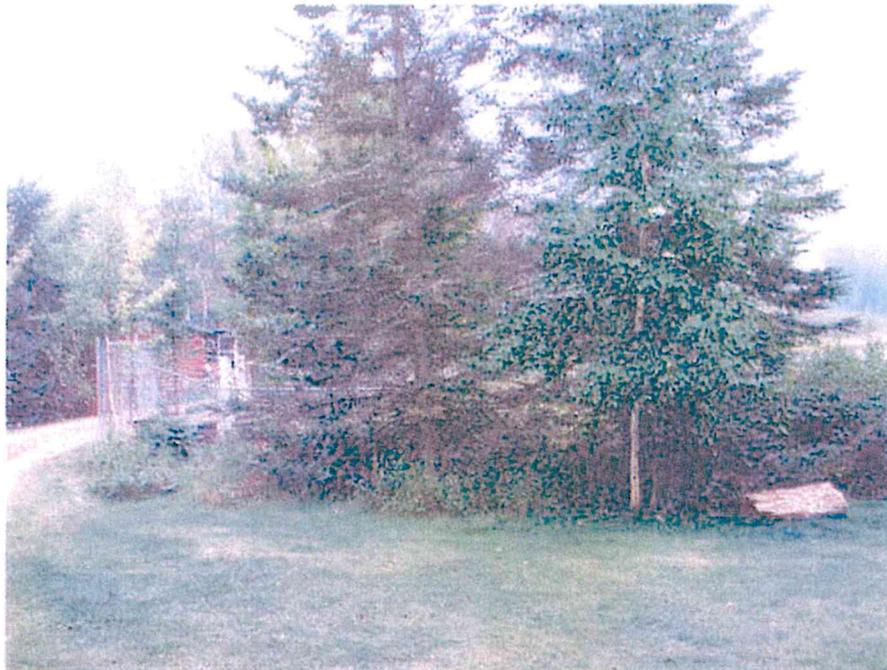
**Figure 8**  
**Trees upper left embankment**

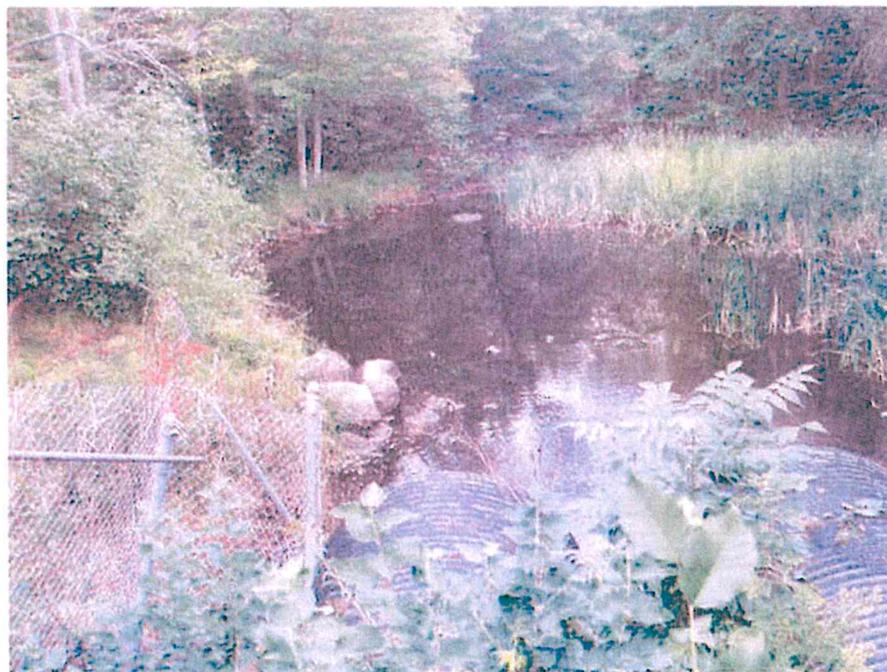
**Figure 9**  
**Tailwater with view of woody vegetation around outlets**
